Manhole Inspection Summary

Manhole # S21G1_014MH

Insp Date: **4/13/08 1:42 PM**

Location Address: **2810 hollins ferry rd**

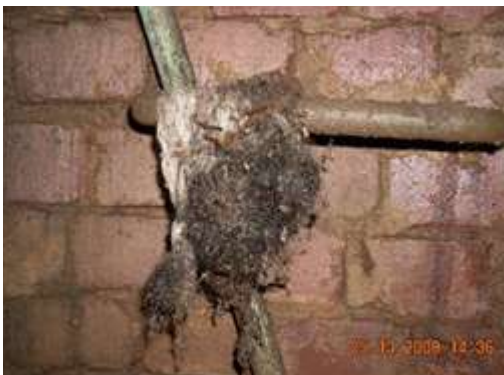
Defect 1

Infiltration: ☐ None ☐ Joint ☐ Cracks ☐ Mortar ☐ Roots ☒ **Wall**

Surcharge ☒ **Evidence Of Surcharge** Depth: **3** (ft.) ☐ Active Surcharge Present

Bench Debris

surcharge evidence, infiltration @ barrel wall

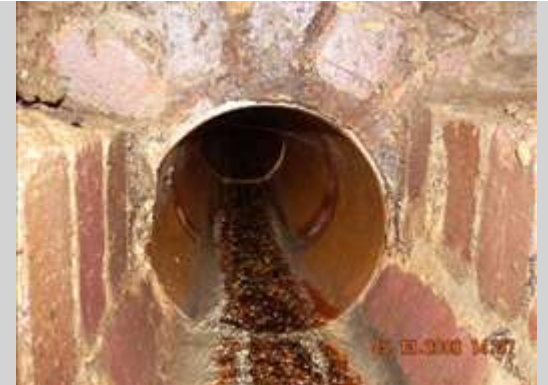
12 O'Clock Outflow

8 in. Circular Gravity Sewer
Pipe Out @ 12 O'Clock

Pipe Height: **8.4** (in.) Rod and Bar (Angled)

Pipe Material: **Clay** ☐ Pipe Lined

Invert Depth: **9.78** (ft.) Flow Characteristics: **Slow**

Infiltration: **None** Pipe Seal Cond: **Sound**

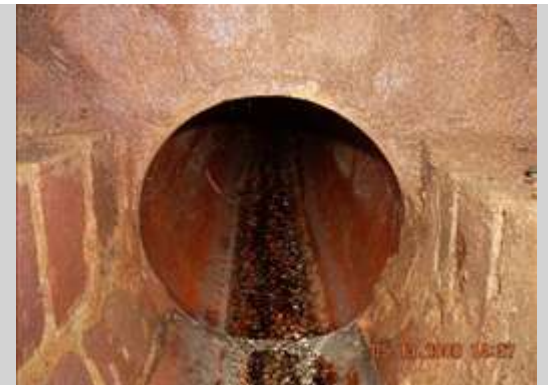
6 O'Clock Inflow

8 in. Circular Gravity Sewer
Pipe In @ 6 O'Clock

Pipe Height: **8.4** (in.) Rod and Bar (Angled)

Pipe Material: **Clay** ☐ Pipe Lined

Invert Depth: **9.51** (ft.) Flow Characteristics: **Slow**

Infiltration: **None** Pipe Seal Cond: **Sound**
